## Case study

### No slip ups in Ambulance Station

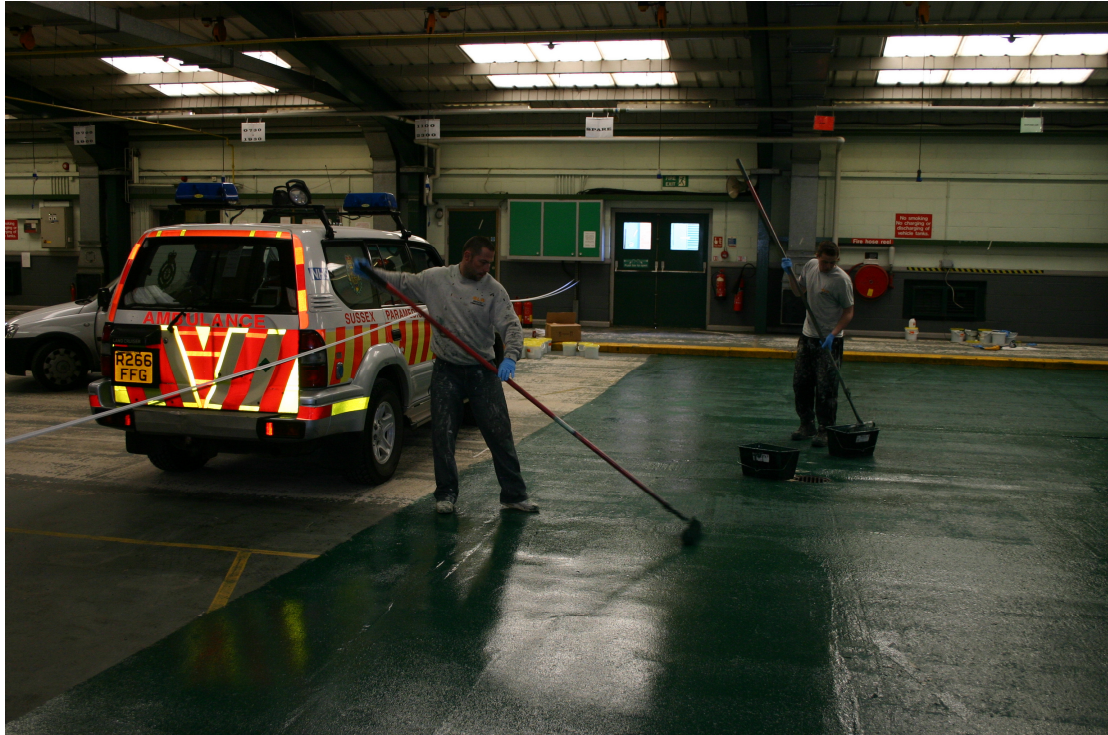
To make the floor of the ambulance station in Sussex not only look good but also stand up to petrol and diesel drippage and provide a safe anti-slip surface for the emergency services staff and maintenance crews, a new high performance epoxy floor coating was applied to the concrete floor slab.

First the existing coating had to be removed from the concrete; this was removed using professional operators and specialist recoverable grit blast machinery. This equipment – available in push along or sit-on – depending on the size of the area to be prepared, fires metal grit or shot at the floor. This breaks away the top surface, in this case epoxy coating with some concrete attached. The enclosed machinery vacuums up the grit together with the epoxy/concrete, separates the two and recycles the grit. The waste material is collected in the vacuum bag and properly disposed.

After preparation the concrete was cleaned and left to dry. Patch repairs were then carried out using RonaFloor Repair 1 Hour 6-50mm. This is supplied pre-packed as a dry powder together with a bottle of liquid, the two are mixed and the mortar is trowel applied to the prepared surface. Ronacrete Rapid Primer is first applied to the surface.

Once the repairs had cured and hardened – just one hour after laying – the first coat of RonaFloor HB100 Rapid was mixed with a drill and paddle and roller applied. Ronacrete's anti-slip aggregate was cast into the first coat to provide the required degree of slip resistance. After just 4 hours the second coat was mixed and applied. This rapid grade allows speedy installation and can be opened to traffic after just 12-24 hours.
