Business Unit: Contractors - Flooring

Date Of Issue: November 2009

Ailing MSCP revitalised by Sika treatment

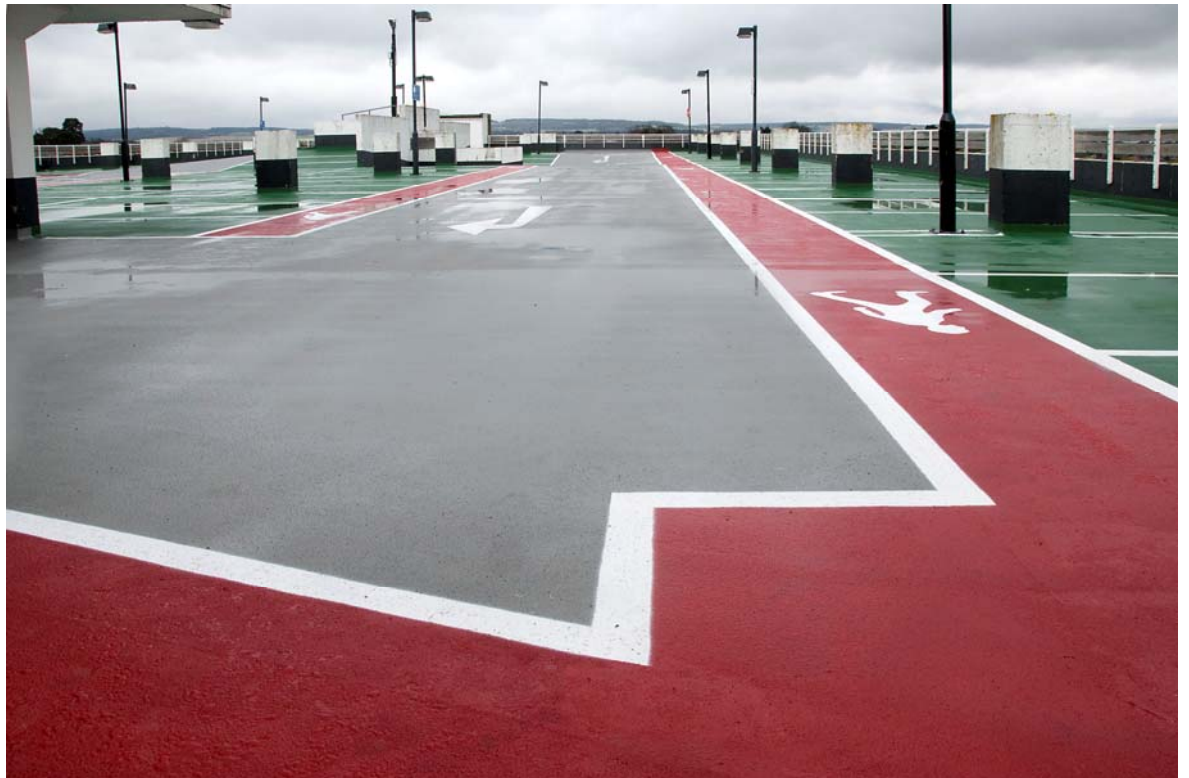
The exposed ramps and top deck of the 5 storey concrete car park leased by Ashford Borough Council were in need of renovation due to spalled concrete and failed car park deck coatings causing water ingress and a build-up of corrosive salts

In addition to the remedial works undertaken, Cemplas repaired the underside of the ramp which was suffering from corrosion due to water and chloride penetration. Sika[®] ArmorCrete[®] flowable micro concrete was used for the large section repairs to the ramp in conjunction with Sika's corrosion inhibitor 'Sika[®] FerroGard[®]' to provide protection against

When considering the products to be used the fastest curing waterproof decking system Sikafloor[®] Pronto was specified and installed to ensure that the car park could be reopened to shoppers as quickly as possible.

Sikafloor Pronto is a car park deck system based on polymethyl methacrylic (pmma) technology comprising of a primer, a flexible waterproof membrane and a seal coat. In average temperature conditions Sikafloor® Pronto can be walked on within one hour of being laid and only two hours before it achieves full cure. Application can still be undertaken in extreme cold temperatures when the cure time is simply extended to four hours. The finished surface is extremely durable with very good mechanical, chemical and UV resistance.
